Jeju Airlines Flight 2216 Crash

Location of Incident	Muan International Airport, South Korea
Date of Incident	December 29, 2025
Date of Report	January 13, 2025

Prepared by: Ben Dellsperger

Incident Description

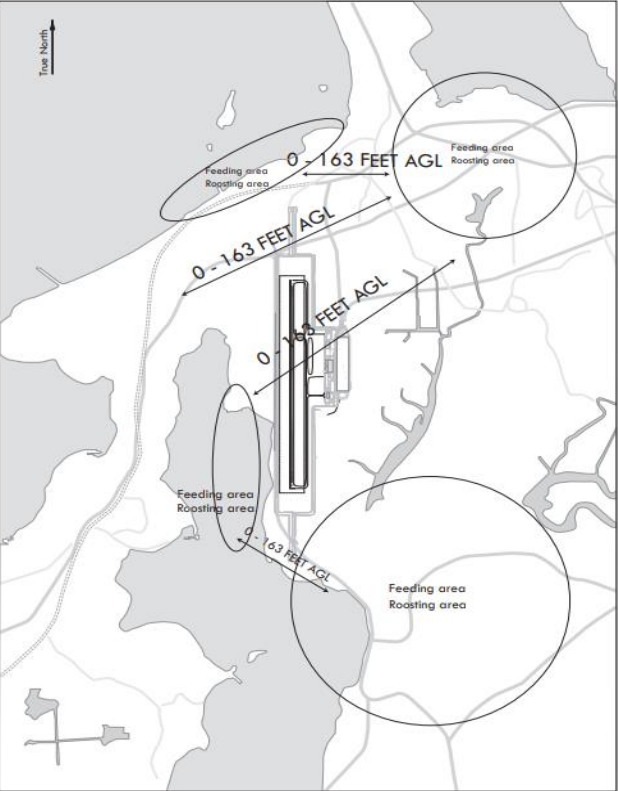
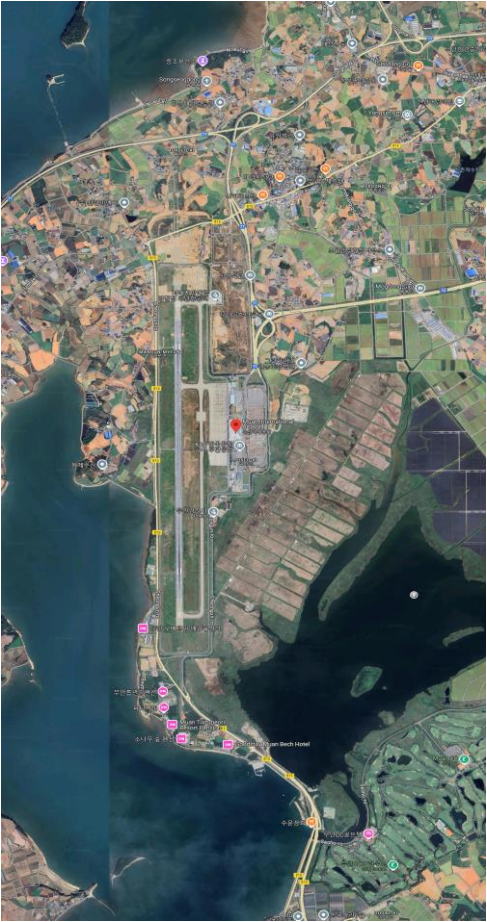
Bird concentration chart around Muan International (MWX)

- Reverse thrust on #1 not working:** Reverse thrust on #1 engine not engaged; Airplane lost #1 engine; Bird strike on #1 engine, on approach; Birds in proximity to runway 01; Airport is in wetland area with lots of birds (evidence: MWX airport has specific instructions for pilots that there are birds near runway 01 and 09).

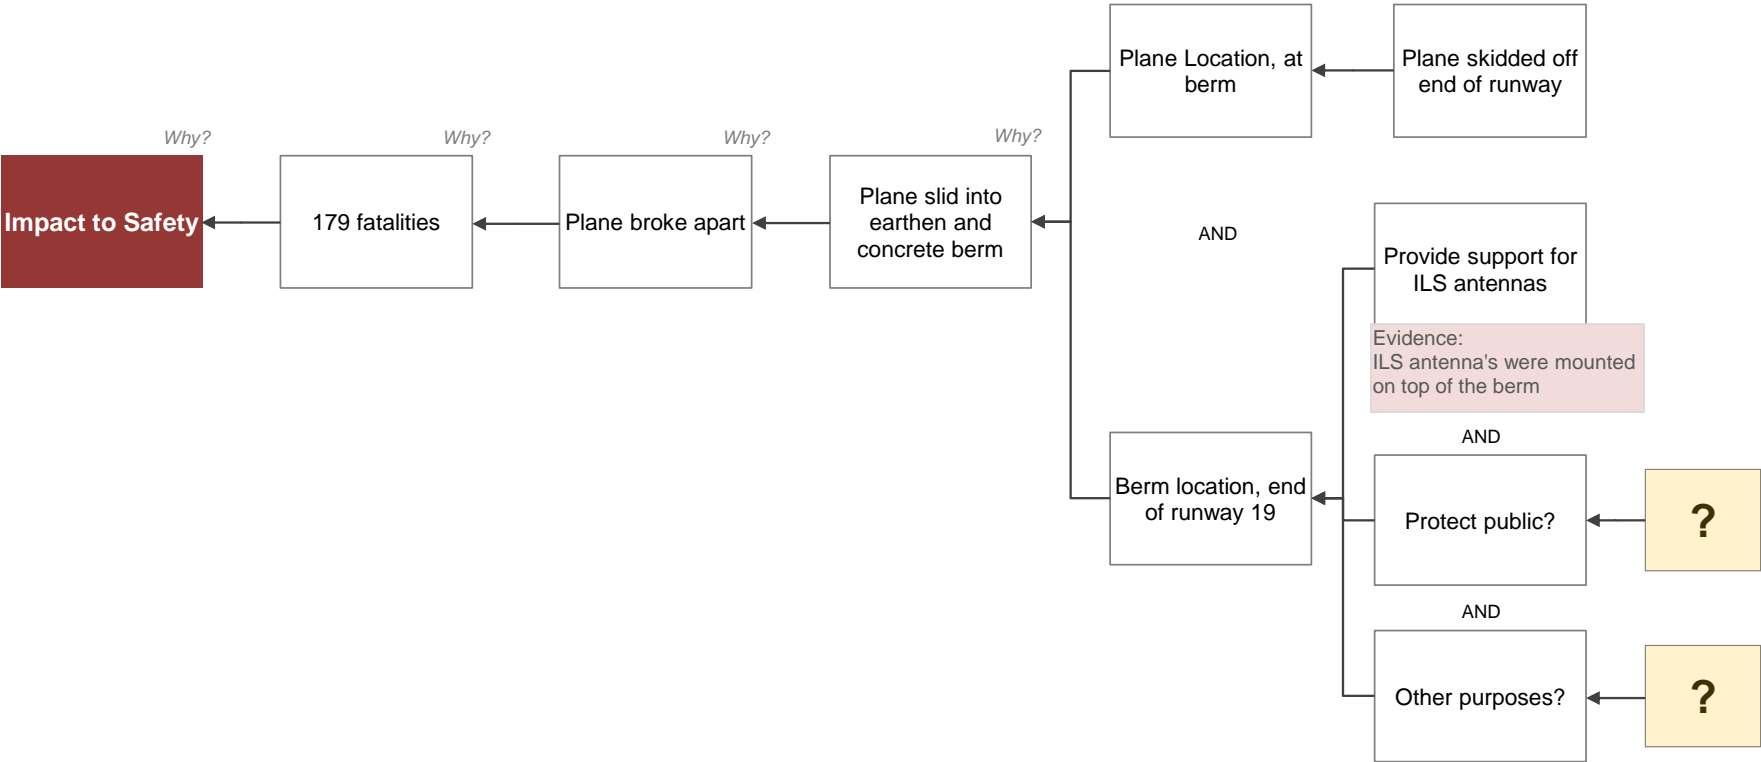
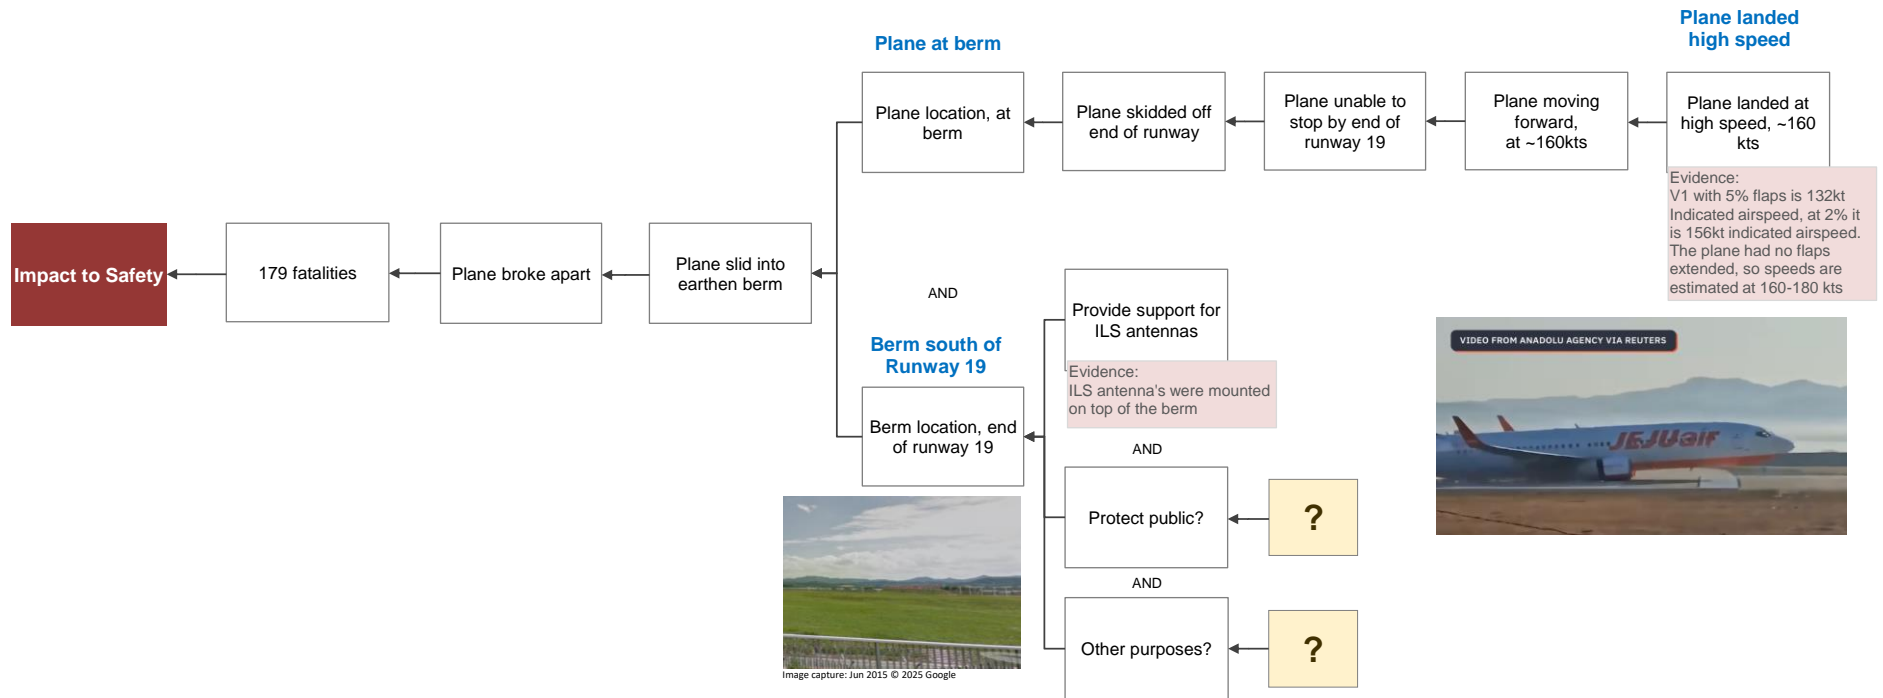
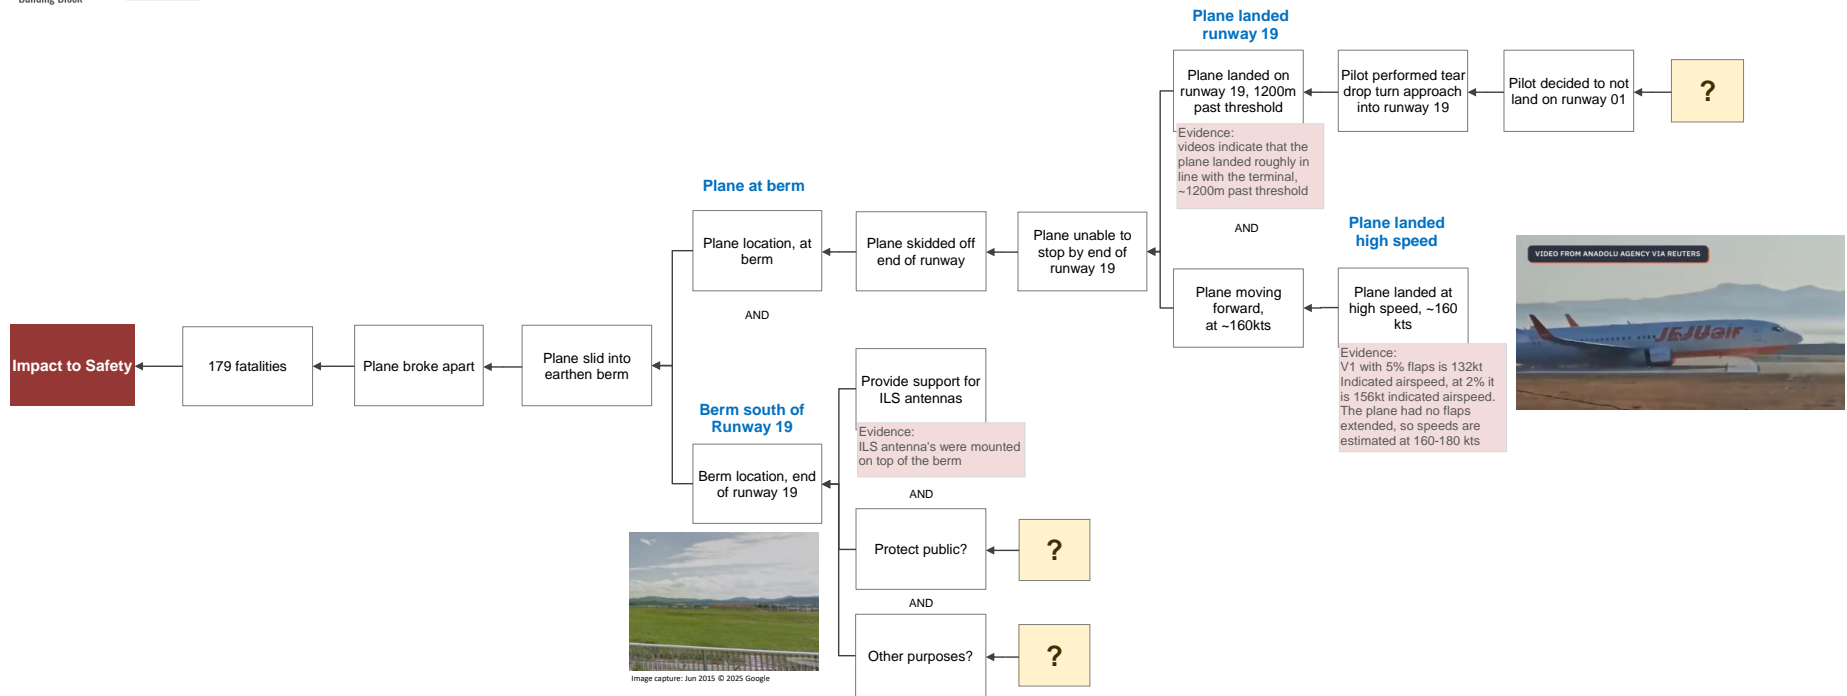
Cause Map™ Diagram

- Plane at berm:** Plane location, at berm; Plane skidded off end of runway; Plane unable to stop by end of runway 19.
- Forward Energy:** Plane moving forward, at ~160kts; Plane landed high speed (evidence: V1 with 5% flaps is 132kt, indicated airspeed at 2% is 156kt, no flaps extended, speeds estimated at 160-180 kts).

- Backward Energy:** Total stopping forces; Reverse thrust on #1 engine not working; Reverse thrust on #2 engine engaged.
- Forward velocity:** Plane continued moving forward.

- Landing gear not down:** Landing gear not down; Brakes ineffective; Hydraulic system failure? (evidence: hydraulic system failure to not deploy landing gear would require hydraulic pump from engine #1 and #2 not working, as well as the backup electrical pumps not functioning).

- EMAS System:** Engineered material arrestor system ineffective; No EMAS installed at Muan International Airport; Not required by International Civil Aviation Organization (ICAO); Believed MXW had sufficient runway safety area (RSA)?

- Belly Landing:** Friction force on aircraft; Belly of aircraft and ground; Pilot decided not to deploy landing gear? (See above).
- Berm south of Runway 19:** Provide support for ILS antennas (evidence: ILS antenna's were mounted on top of the berm); Protect public?; Other purposes? (evidence: What is the point of the berm? The berm is very robust and solid (earthen berm with concrete underneath) - this seems overkill for supporting of the ILS antennas. ICAO doesn't provide any guidance for ILS antenna support compared to the USA which specifies they must be frangible).

- Tail wind on runway 19
- Flaps inoperable? (evidence: videos with the bird strike appear to show the landing gear deployed and flaps down, indicating that at approach on runway 01, the gear and flaps were operable, but were retracted)
- Hydraulic system failure?
- Pilot decided not to deploy flaps?
- Manual release of landing gear not utilized (evidence: in the event of a hydraulic pressure loss, the landing gear can be manually extended using backup system located in cockpit)
- Pilot decided not to deploy landing gear?

- What was the condition of the aircraft post bird strike, how did the condition of the aircraft contribute to the decision making of the pilot. Why did he retract gear and flaps
- Understanding the design of the airport, and why the berm, the lack of an EMAS and the location of the airport in proximity to high volumes of migratory birds needs to be understood
