NYC Helicopter Tragedy - East River

March 11, 2018

Cause Mapping®

15-Why Cause Map™

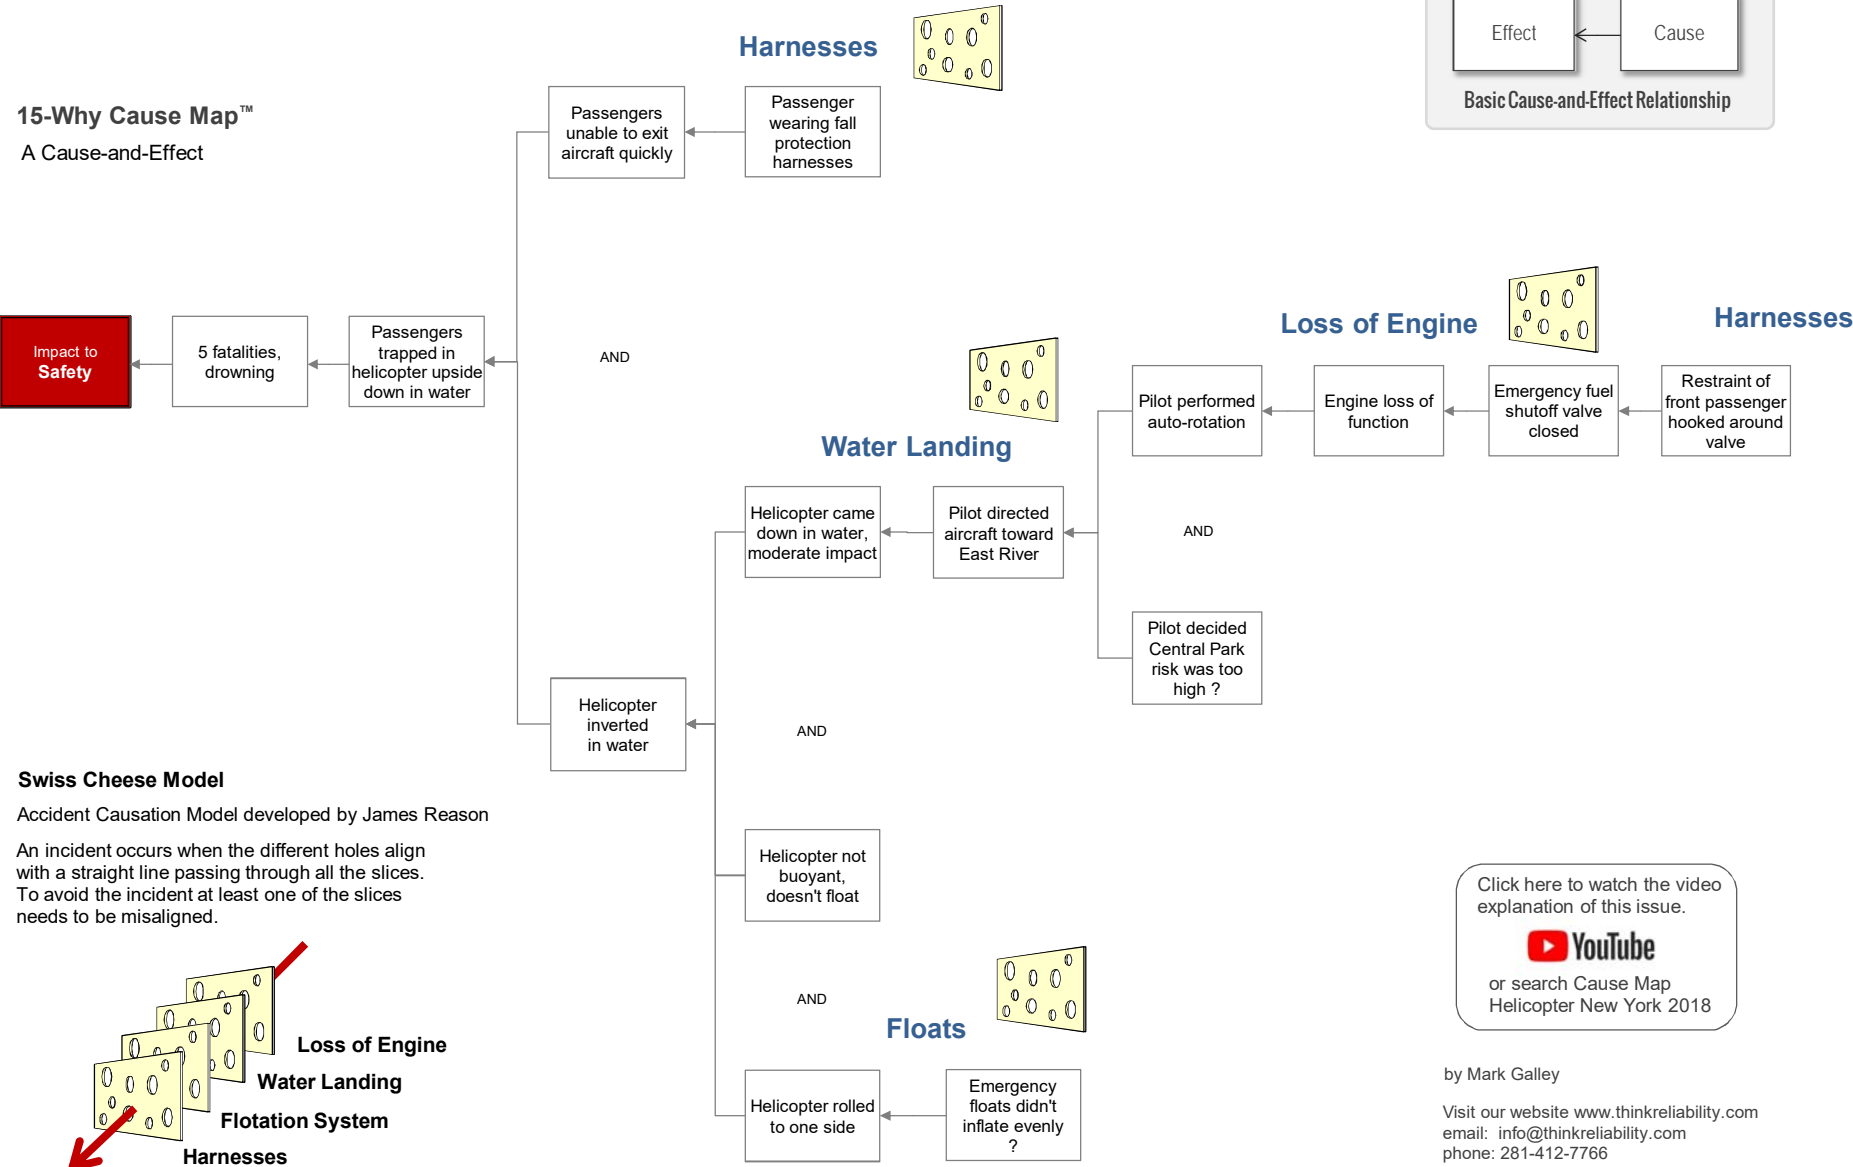
A Cause-and-Effect
